RESEARCH MEMORANDUM

EXPERIMENTAL INVESTIGATION OF SCREECHING COMBUSTION

IN FULL-SCALE AFTERBURNER

December 4, 1953

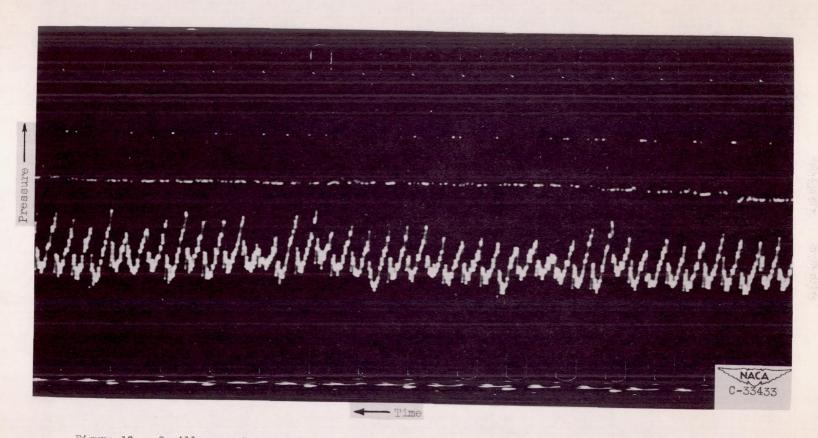
The wave shape of screeching combustion is illustrated by the trace presented in figure 16. The wave shape resembles somewhat that of a cyclic detonation or explosion, in that the rarefaction period is longer than the compression period. Wave shapes recorded are subject to some distortion caused by the instrumentation.

Figure 16. - Oscilloscope trace showing wave form of low-intensity screech taken with acoustic probe.

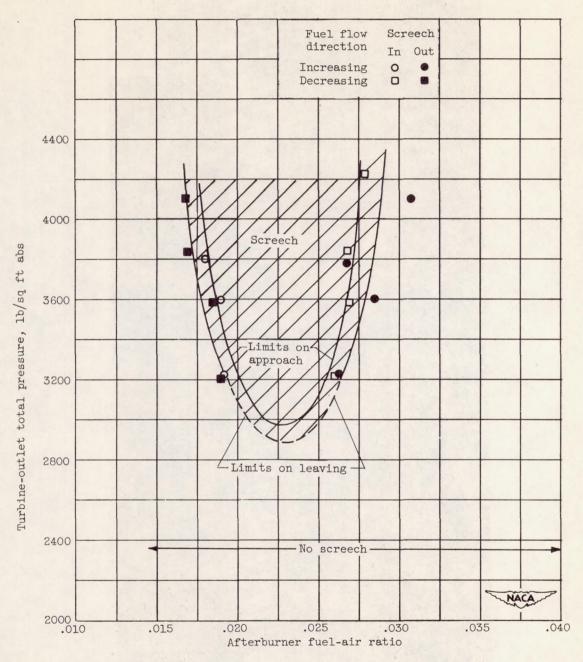
The range of afterburner fuel-air ratio over which screeching combustion was encountered generally increased as burner-inlet total pressure was raised. This trend is illustrated in figure 17, which also indicates the hysteresis that existed in the screech limits for most configurations. At a given burner-inlet pressure, the range of fuel-air ratio over which screech existed was narrower when approaching the screech zone than when leaving the zone after screech was encountered. (The fuel-air ratio presented in figure 17 and subsequent figures is the ratio of afterburner fuel flow to unburned air entering the afterburner.) Over the limited range of burner-inlet temperatures investigated, there was no consistent effect of inlet temperature on the screech limits. These observations confirm those of reference 3, which shows no effect of inlet temperature on screech limits.

Figure 17. - Variation of screech limits with pressure level of operation for configuration 37.

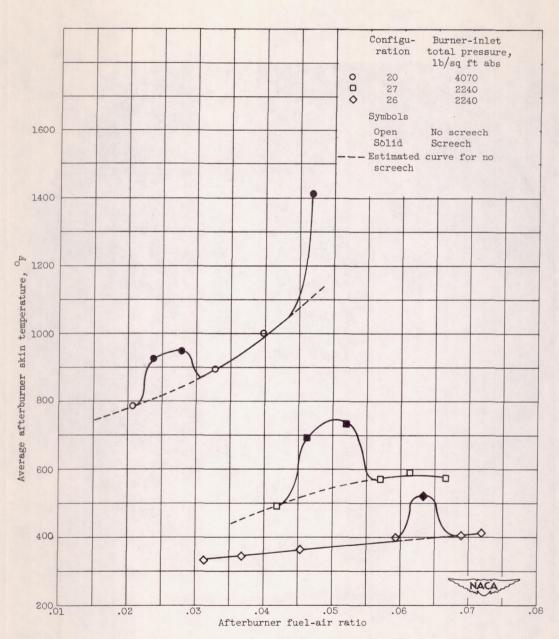
Another observation was that the afterburner shell and exhaustnozzle segments overheated in many cases during operation with screeching combustion. It appeared that during such operation the flame became
very turbulent and spread rapidly in much the same manner as that reported
in reference 5. Based on this observation, it was believed that the
distance between the outer gutter of the flame holder and the burner wall
might be a factor influencing screeching combustion.

Figure 18. - Effect of screech on afterburner skin temperature.

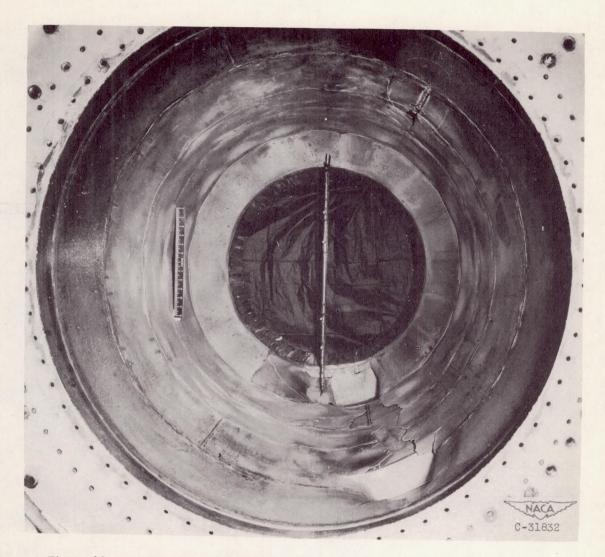
Figure 19. - Destruction of combustion chamber due to screech. Configuration 36.

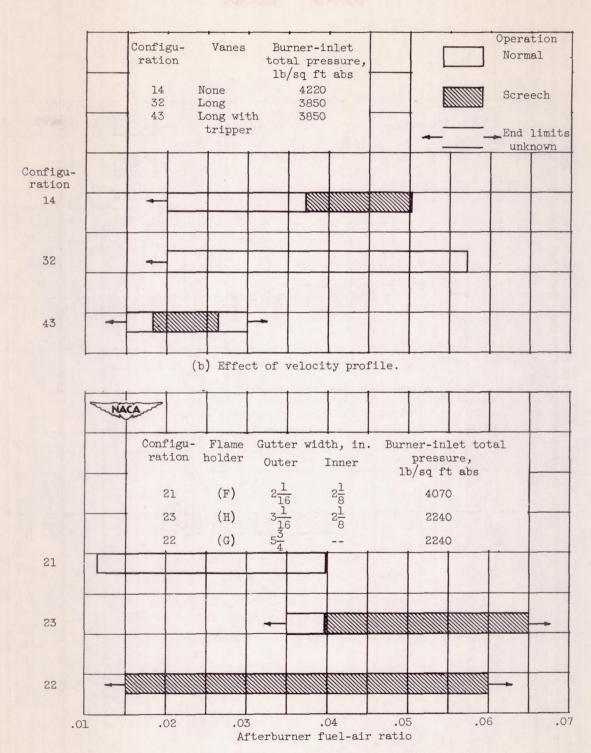
Further comparison of configurations 21, 22, and 23 led to the belief that flame-holder gutter width could have been the influencing factor instead of distance from the outer gutter to the burner wall. Figure 22(c) presents an evaluation of these three flame holders. One of these was a flame holder having a single V-gutter with a gutter width of $5\frac{3}{4}$ inches and an outer diameter of 28 inches (flame holder (G), configuration 22). Screeching combustion was encountered with this configuration over the entire operable range of fuel-air ratio at a burner-inlet total pressure of 2240 pounds per square foot absolute (fig. 22(c)); in fact, the observation of an audible sound with the afterburner inoperative suggested that this flame holder was inducing a flow instability even in the absence of combustion. The flame holder with gutter widths of $2\frac{1}{8}$ and $2\frac{1}{16}$ inches (flame holder (F), configuration 21) did not screech

at burner-inlet total pressures as high as 4070 pounds per square foot absolute; while the flame holder with an outer-gutter width of $3\frac{1}{16}$ inches (flame holder (H), configuration 23) screeched at a burner-inlet total pressure of 2240 pounds per square foot absolute (fig. 22(c)). The observations made with these three flame holders strongly suggested that flame-holder gutter width was an important factor.

(c) Effect of flame-holder gutter width.

The most pronounced effect of flame-holder geometry on screeching combustion was found to be that of varying gutter width. Reducing gutter width reduced the tendency of the burner to screech, the flame holders with the smallest gutters being screech-free. Screeching combustion was also eliminated by installing a long water-cooled cylindrical splitter on a large single-V-gutter flame holder. The function of this splitter was believed to be either that of preventing interaction between the vortices from opposite edges of the gutter and the resultant shedding of vortices, or damping of the acoustical oscillations believed by some experimenters to be the cause of screech.

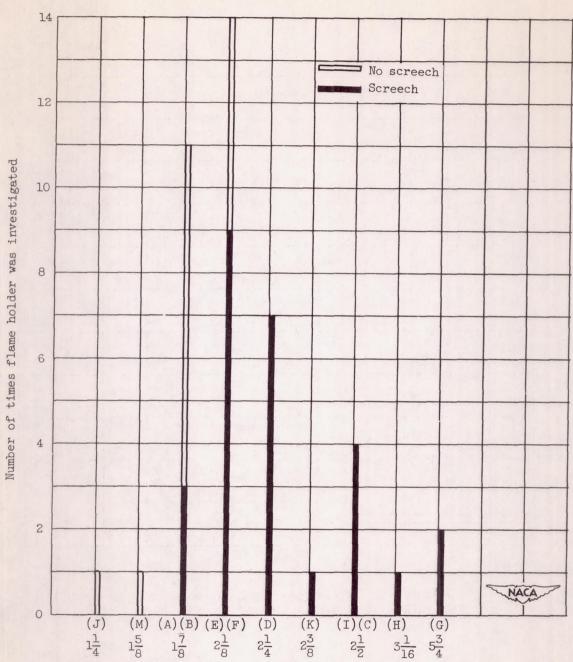
Figure 23. - Variation of flame-holder proneness to screech with gutter width at burner-inlet total pressures from 3850 to 4220 pounds per square foot absolute.

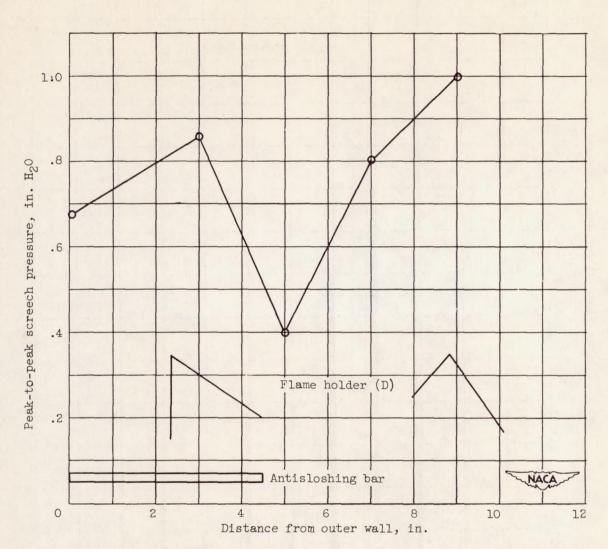
During operation with configuration 39, an acoustic probe, located a few inches downstream of the flame holder, was traversed radially inward from the afterburner shell during a mild screech condition. From observation of the panoramic sonic analyzer, there was no change in the frequency of screech across the burner. There was a slight variation in the amplitude of pressure pulsations, as shown in figure 24; but no particular significance has been attached to these measurements, since it has not been possible to correlate them with any acoustical oscillation that might exist in the burner. It should be noted that this configuration included a set of small antisloshing vanes inserted in an attempt to disrupt an acoustical oscillation of this type. It is now believed that these vanes were too small to have any measurable effect on screeching combustion.

Figure 24. - Variation of screech pressure amplitude downstream of flame holder. Configuration 39.
